DRF1 cavity Power Amplifier repair**Description:**

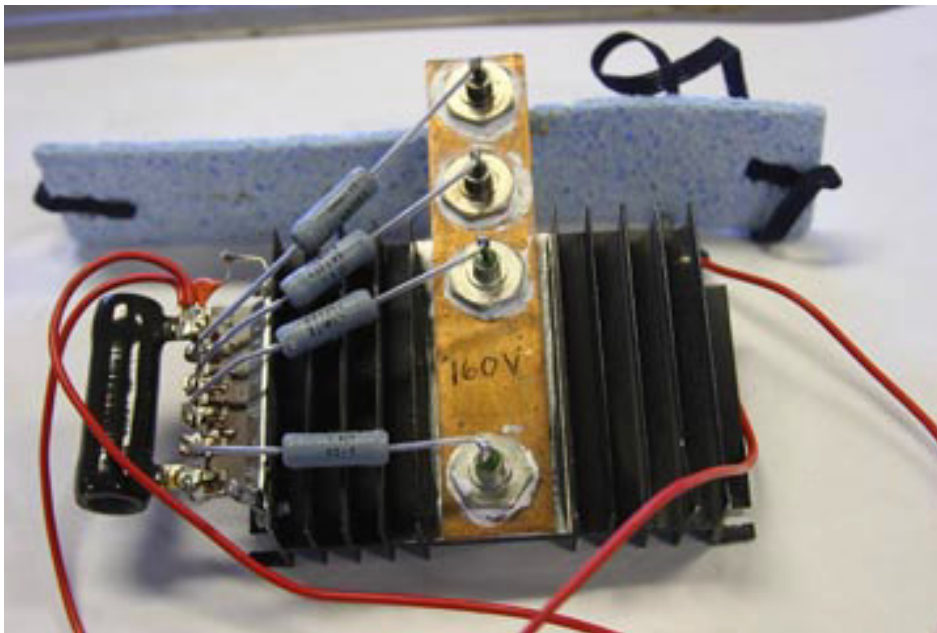
Zener Diode Stack
Located within the top half of PA

(2) Bias zener diode(s) stack open.

Yes, it does happen. AND it will happen again. This failure will not have a catastrophic symptom. Instead, you will find that the cavity output is low. This is easily confused with weak output tubes NOT ALWAYS TRUE. Since the tubes are with no clamping from the zener stack they will go deeper into self cutoff during the drive pulse. This inhibits the output from fully appearing at the plates. The bias supply will show the correct voltage (~155V) on the front panel meter and all other appearance will seem to be correct. Watch out for this one! A way to test this is to use an ohm meter with the Negative lead at the bias input. This should read as a normal diode. Remember that there are a number of parallel components (resistors and large capacitors) so refer to the drawing for a clear understanding of its electrical environment.

Replacements for the zener stack are located in AP50 on the accumulator side in a cabinet facing the walkway to the counting room. Refer to the picture in the back of this note for the zener assembly identifying features.
